# **JAPANESE COOPERATION FOR URBAN PLANNING IN THE OLD CAPITAL OF DAMASCUS**

## **A CASE STUDY OF “RESTORATION-TYPE” FAÇADE IMPROVEMENT**

**Matsubara Kosuke**<sup>1</sup>,

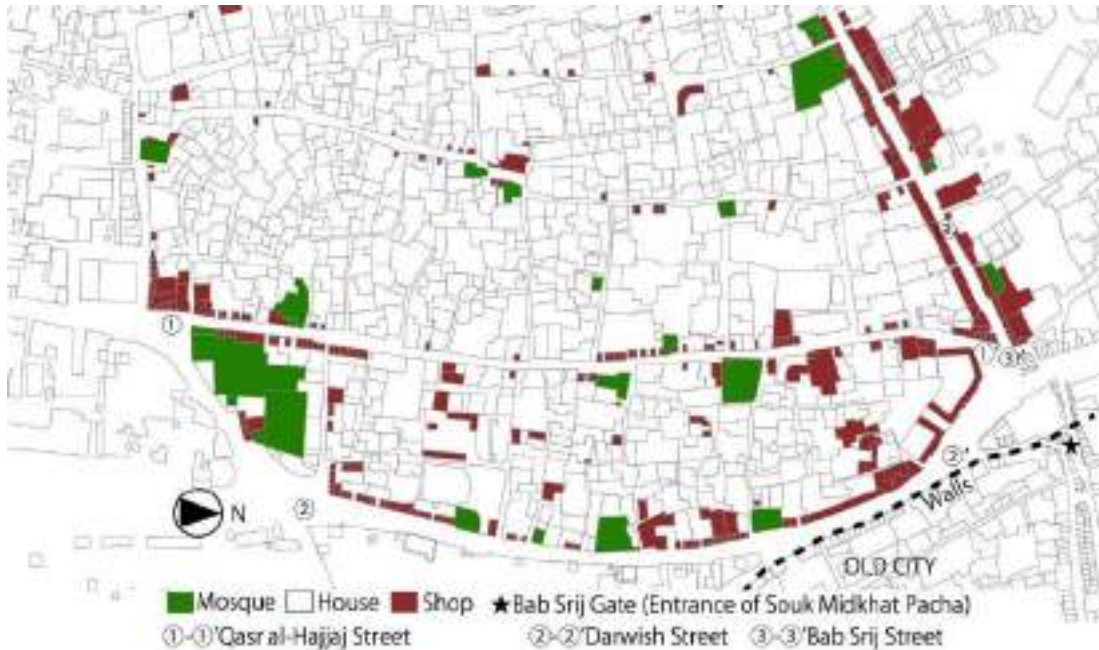
Basic actual land use is for housing but some houses have small shops on the first floor (Fig. 1). The street, which is 514m in length and between 4 and 6 meters in width, is a one-way street but traffic is heavy and it is not safe for pedestrians.

Figure 1: Actual Land Use along the Street

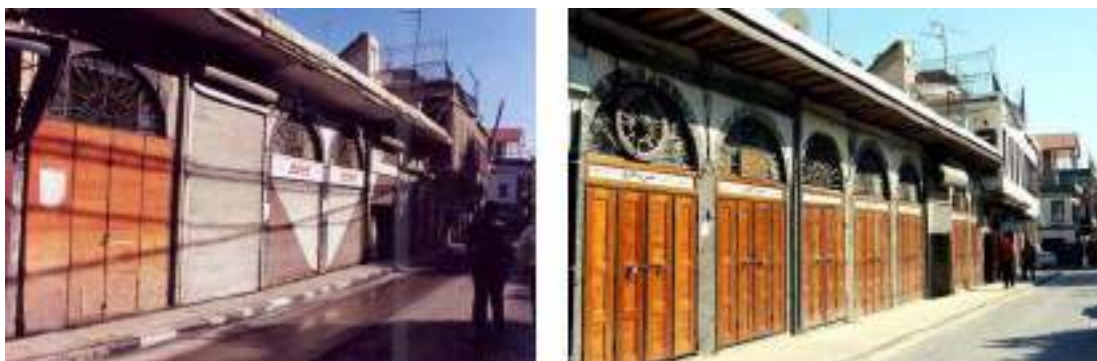
In fact, the situation on *Qasr al-Hajjaj* Street is quite different from that of *Souk Midkhat Pacha* which was the object of a façade improvement project in the past (Photo 1). Past projects included some radical methods such as replacing shutters with neo-traditional wooden doors or apparent unification of building heights and wall finish. However, these radical methods are still debatable since one of reasons that the old city is attractive stems from its spatial variety.

Photo 1. Case of *Souk Midkhat Pacha* (Left: Before Improvement, Right: After Improvement )

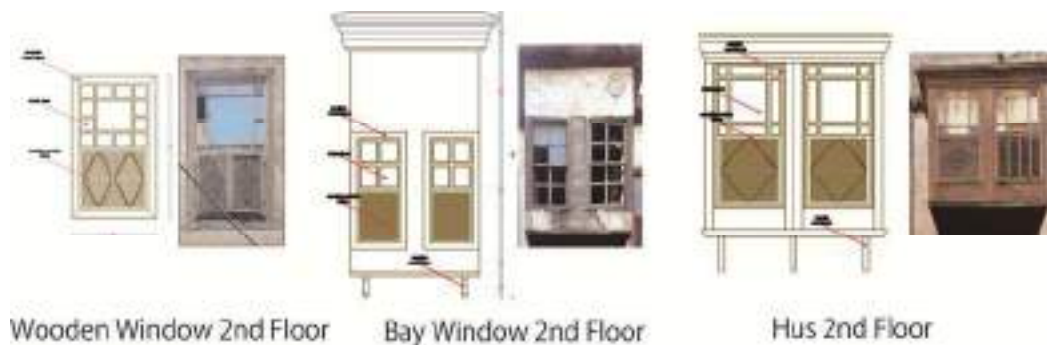
Figure 4: Examples of Elements (Windows on the 2nd Floor and Decoration)

The windows on the second floor are many and huge; their total surface is the second largest element of the whole façade. There is unity of size and form and window frames are traditionally decorated. Movable wooden window covers called *Hus* (حصص), which means “wooden sculpture”, covers the windows. There are also bay windows which give the impression of three-dimensionality to the street landscape. Not so much difference is found between the windows of the 2<sup>nd</sup> floors and those of the 3<sup>rd</sup> floors. From the viewpoint of window frame materials, the number of wooden and iron windows are almost equal on the 1<sup>st</sup> floors, while there are many more wooden windows than iron windows on the 2<sup>nd</sup> floors. For this reason, it is assumed that people don’t hesitate to replace wooden frames with iron frames for windows on the 1<sup>st</sup> floors (these being small and not unified) while they tend to conserve traditional style and materials on the 2<sup>nd</sup> floors. On the whole, windows, especially those on 2<sup>nd</sup> floor and above, are regarded as important original elements to be restored.

Traditional decoration includes *Shurfa*, which are wooden window covers, *Hus* which are bay windows that allow people to see the street while being hidden themselves and *Hujur* (الحجر), which are traditional stone tiles that decorate the rims of doors. Some of these decorations have been replaced by iron materials. The bay windows of the 2<sup>nd</sup> floors and above give an impression of three-dimensionality to the landscape. The existence of revealed beams supporting bay windows and of wooden eaves also modulates the landscape. These elements are the result of extensions by the habitants and are a typical traditional townscape. Due to their delicateness and the vagueness of boundaries, it is difficult to grasp the exact number of these decorations. However, traditional decoration is certainly considered as an original element to be restored.

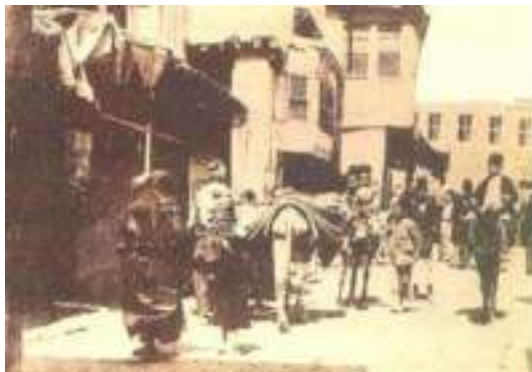
Photo 2: *Souk Al-Taweel* in 1860

Historically speaking, the frontage of shops was equipped with folding wooden doors. Although it is unknown when the wooden doors started to be replaced by shutters, there is photographic evidence from around 1860 showing shutters in *Souk al-Taweel* which are assumed to be the first shutters used in the old city (Photo 2). The use of shutters, which are superior to traditional wooden doors in terms of safety and ease of maintenance, rapidly spread throughout Damascus. It was accelerated by the introduction of modern apartments.

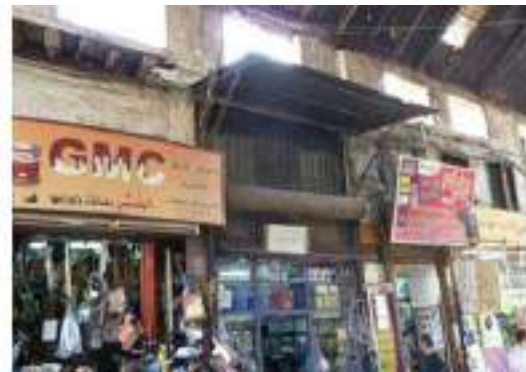
Shutters are hand-operated and rolled into boxes at the top of the frontage when the shops open. The boxes double as signs for the shops (Photo 3). The boxes are made of iron and there is no unity of form, color or size. However, they have the capacity to store a rolled shutter and this makes them protrude around 1m into the street. These boxes hide the arches or arch-type transoms recognized as original factors and as a result, the percentage of transoms is only 4.1 % of the number of all the shop frontages in the street. Moreover, the row of boxes, which are gaudy and not unified, also hide the revealed beams and eaves and spoil the three-dimensionality of the street landscape. These are the most serious obstructive elements in the original façades (Photo 4).

Photo 3: Boxes as Signs

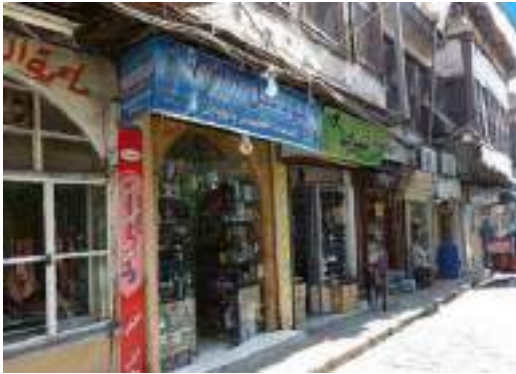
Photo 4: Boxes hiding Arches

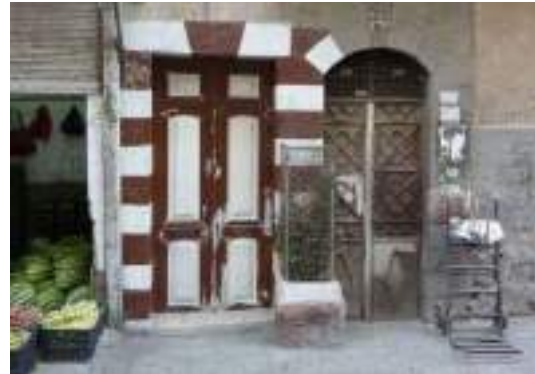
Photo 5: Iron Door (right)

Decrepitude causes materials to change. Doors and window frames that were originally made of wood tend to be replaced by iron (Photo 5). Makeshift repairs of collapsed walls using zinc or haphazard brick-laying is also regarded as an obstruction to the original façade. Even some traditional elements such as *Shurfa* and *Hus* have been replaced with iron or concrete materials. This change of materials must be based on demands for strength because these decorations have an aspect of practical use. However, these synthetic materials are an obstruction that do not match the wooden elements.

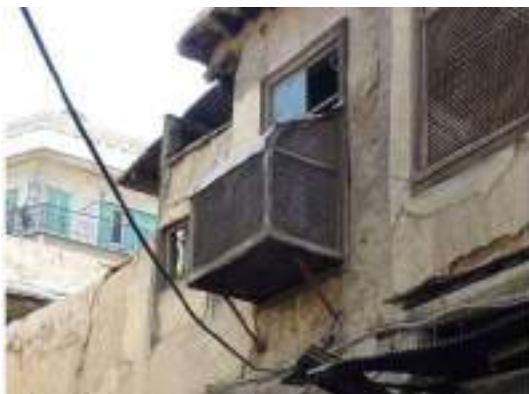
There are other obstructions excluded from the analysis in Chapter 3: the jumble of electricity cables on the walls of houses (Photo 6) and electricity boxes and exterior parts of air conditioners. Thick ducts on the walls of bakeries also obstruct the original façades (Photo 7).

Photo 6: Electricity Cables on *Hus*

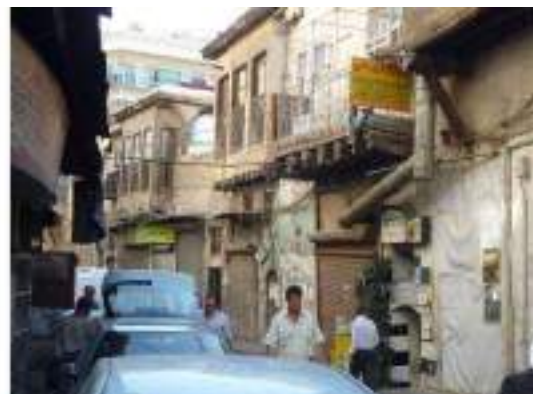
Photo 7: Duct on Bay Window
